Inspected for:
Zaphod Beeblebrox
3316 Golgafrincham Place
Margretha, CA

Full Circle Inspections, Inc.

05/13/2021

Re: 316 Golgafrincham Place
Margretha, CA

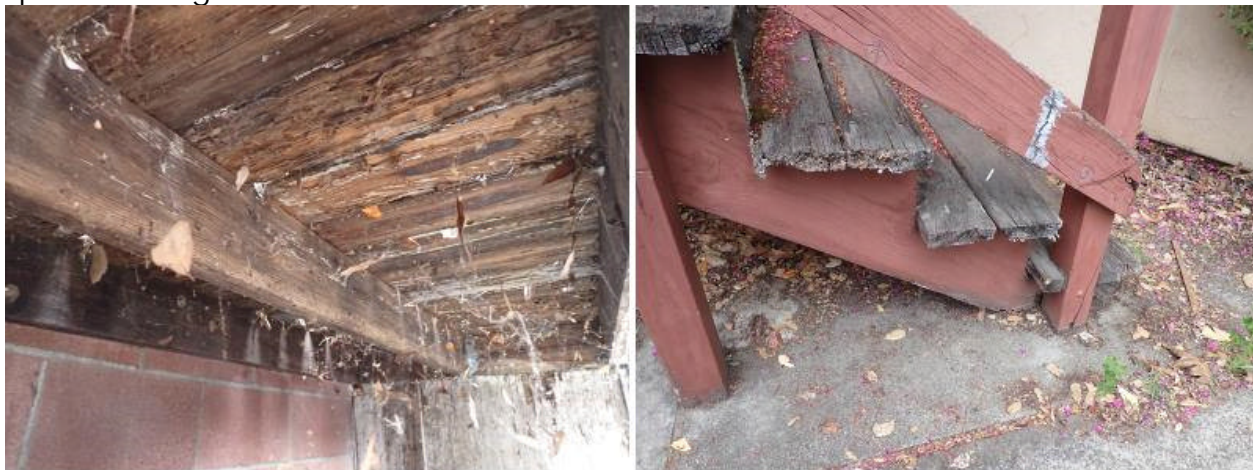
Steps :& Landing

Decayed/damaged wood found at framing and steps. These steps are potentially hazardous. Any damaged wood should be replaced to prevent injury.

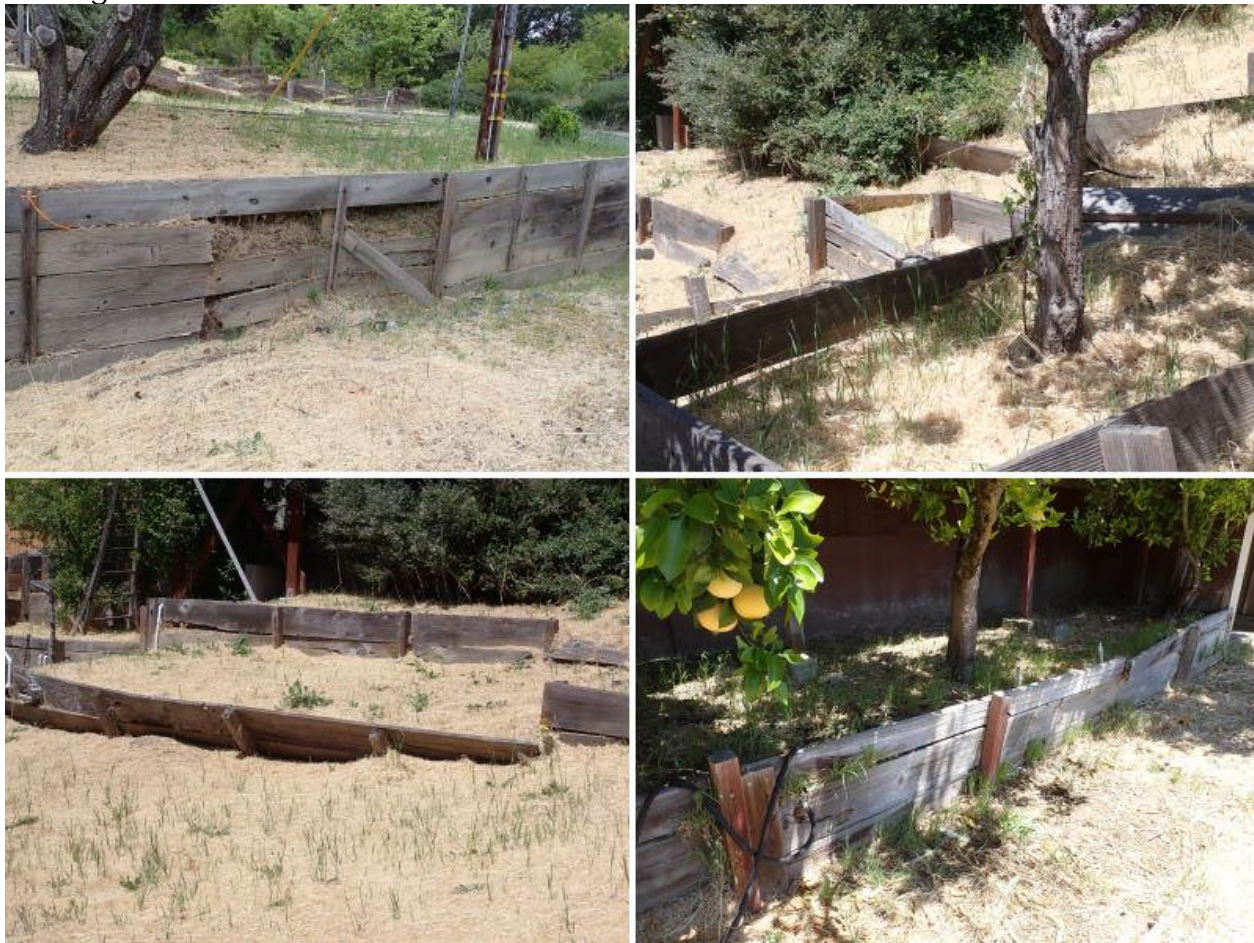
Retaining Walls:

Walls consist of wood.

The wood retaining walls are damaged/failing. This wall should be replaced to properly hold back the soil as originally intended. A licensed foundation or masonry contractor should be consulted for further review and corrections, as needed.

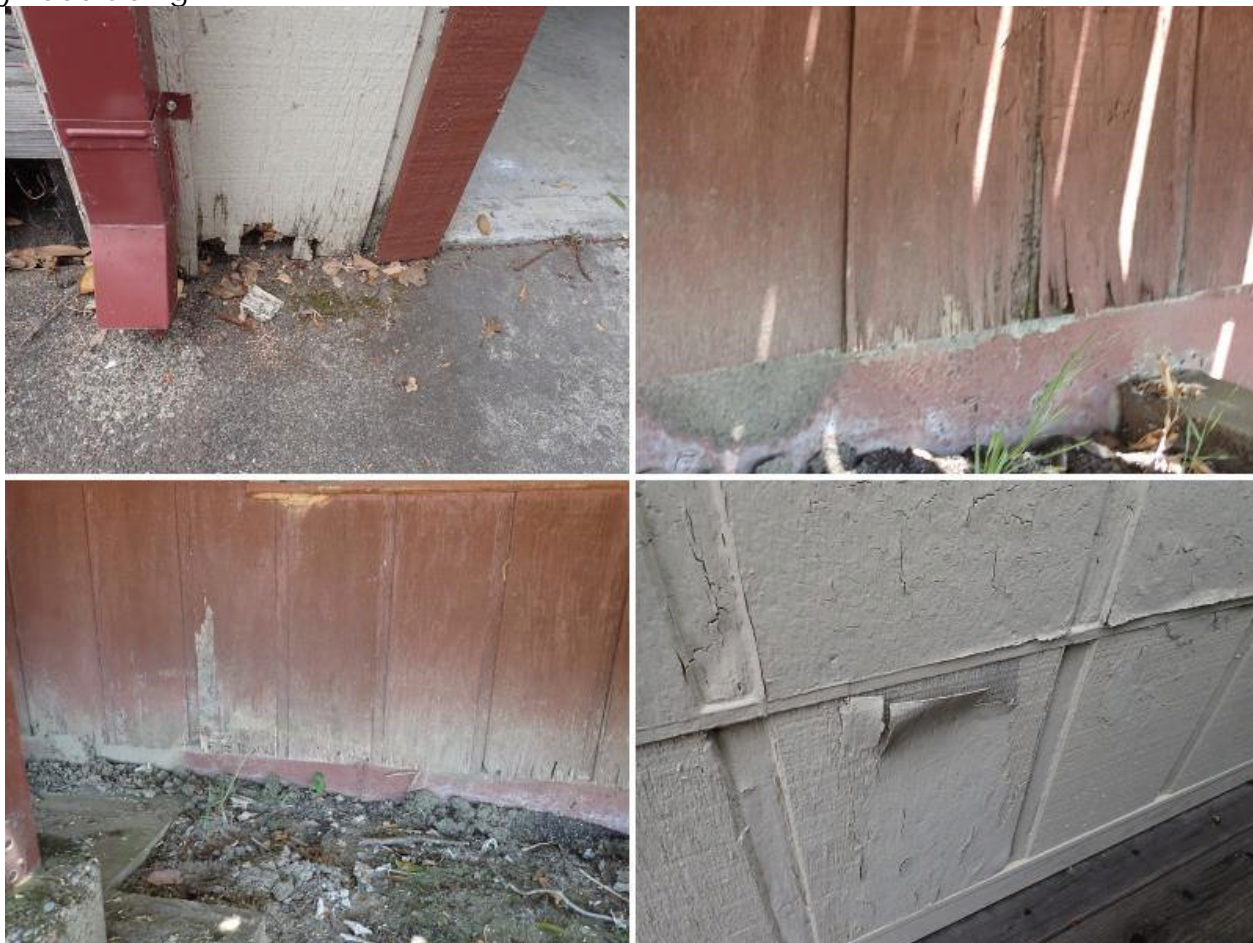
Manufactured Siding:**Plywood Siding:**

Decayed/damaged sections of siding were observed at the front. As this is not an inspection for wood destroying organisms (WDO) and other areas of damage may be present, I recommend review of this home by a California Structural Pest Control Board licensed "branch 3" inspector and corrections, treatment, or repairs made, as needed.

Surface of plywood siding is cracked, which indicates the paint is aged/deteriorating. These small voids in the protective layer of paint will allow moisture to soak into the siding, which will eventually cause the layers or "plys" of the veneer to delaminate and peel off. This type of damage usually takes years to occur and can be prevented by proper preparation and painting of siding. While painting is not immediately imperative, the paint will continue to deteriorate. The sooner the exterior is painted, the less weathering will have occurred and therefore less surface preparation will be required. Surface preparation should include scraping or pressure washing to remove loose paint, caulking or filling of voids and seams, and priming with a good quality primer/sealer.

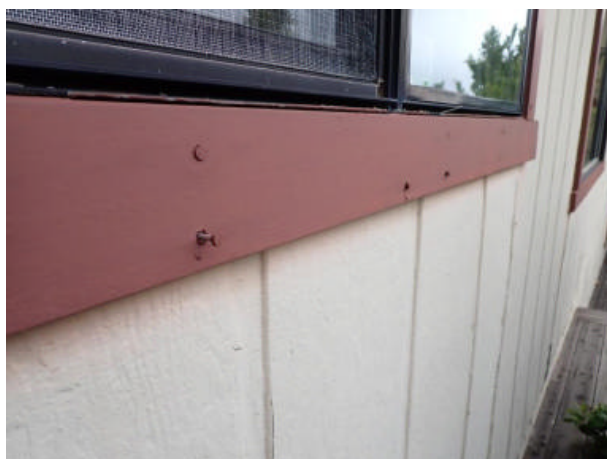
Nails are loose at some areas. Trim should be renailed or replaced, as needed.

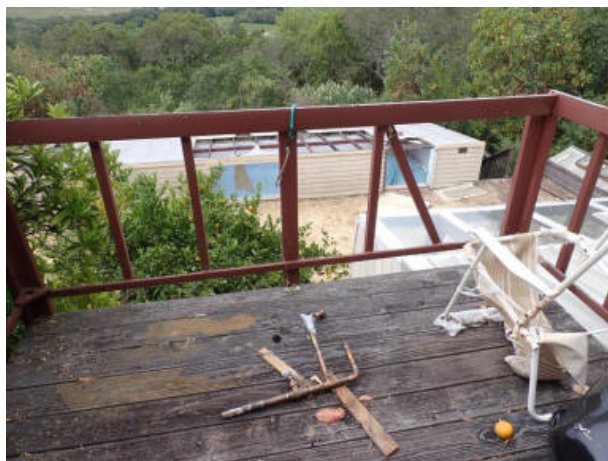
Guardrail is inadequate. The guardrail is weak, spacing between members is excessive and the height is less than currently allowed. The spacing could allow small children to fall through the openings.

Current construction standards require that spacing between guardrail members be constructed to prevent a 4 inch diameter sphere from passing through and minimum height is 42 inches from the deck surface. My primary recommendation is to replace this guardrail.

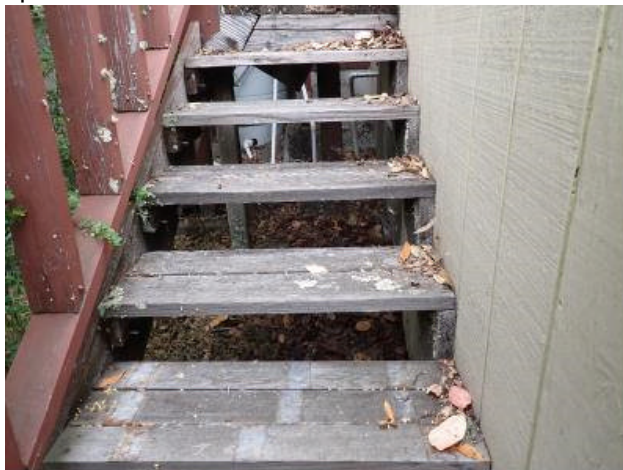
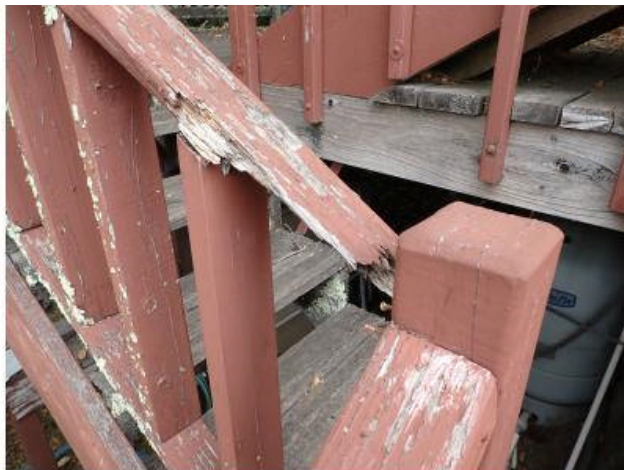
Steps/Stairs:

Wood is decayed/damaged at the step framing, railings, and treads. Some of the steps are weak and potentially unsafe. I recommend replacement of any damaged stairs.

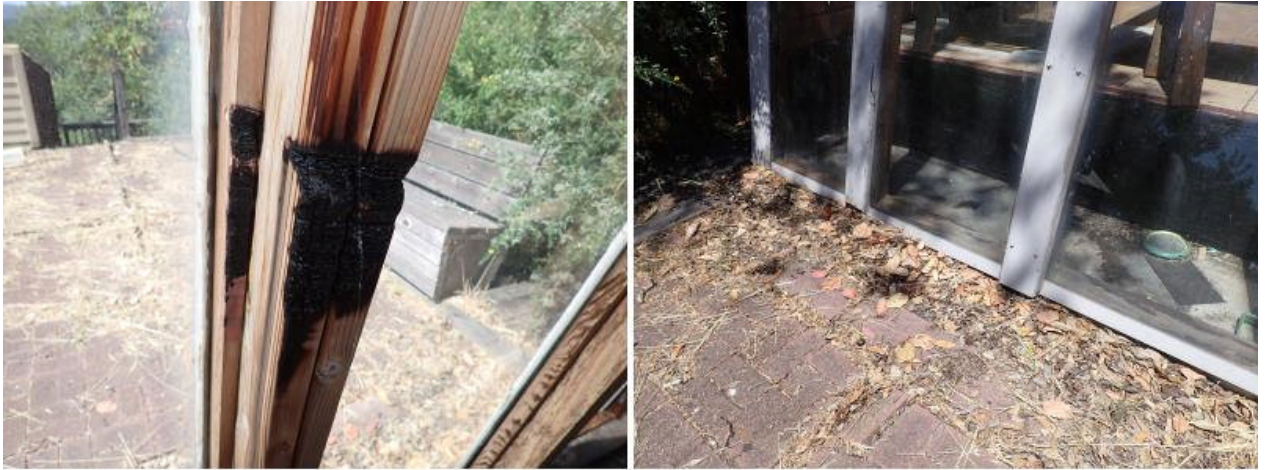
Frame:

Some of the wood is charred. This does not appear to have significantly compromised the structure.

Wood is in contact with soil, which will result in decayed/damaged wood to deteriorate. Wood members should be supported on concrete or otherwise isolated from contact with soil.

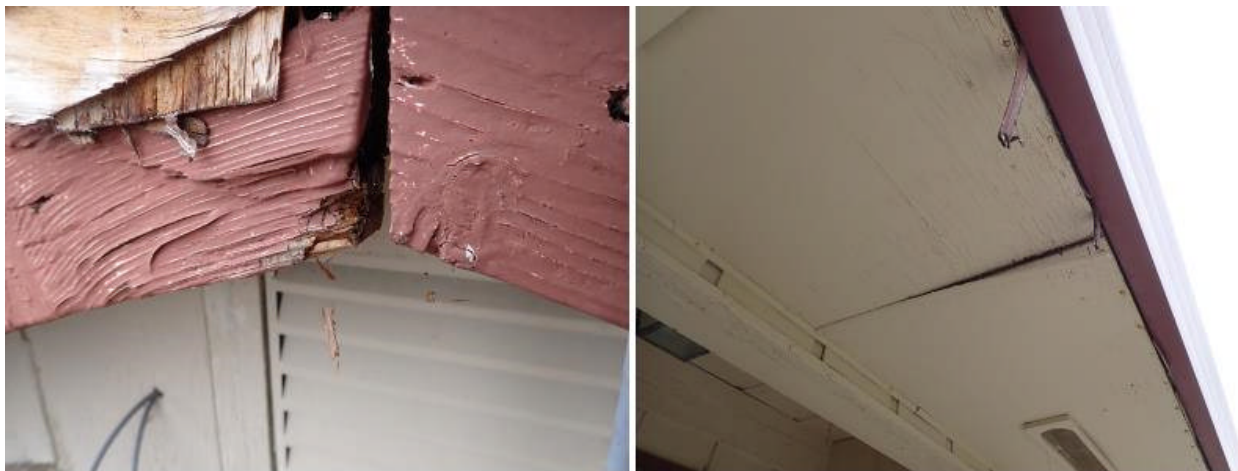
Eaves:

Some decayed/damaged wood found at the eaves. As this is not an inspection for wood destroying organisms (WDO) and other areas of damage may be present, I recommend review of this home by a California Structural Pest Control Board licensed "branch 3" inspector and corrections, treatment, or repairs made, as needed.

Eaves are enclosed with soffits. Soffits are loose at a few locations. I recommend renailling/corrections, as needed. Visual inspection of soffited eaves is restricted.

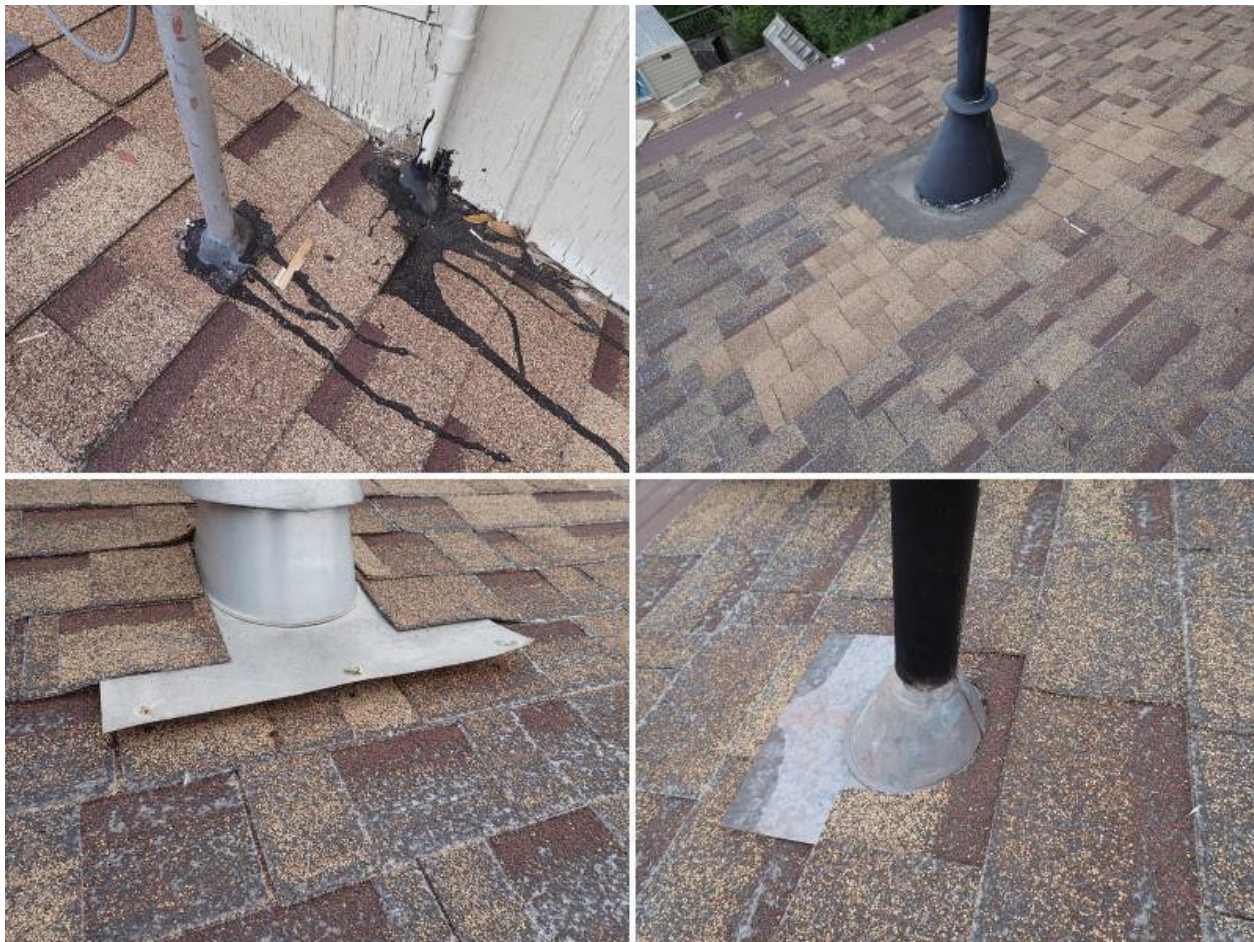
Penetrations:

No flashings present at the two sprinkler penetrations. This should be corrected by a licensed roofing contractor concurrently with roof replacement.

Asphalt patching compound (mastic) has been applied to some roof penetration flashings. This indicates an active or intermittent leak. While mastic can be useful as a temporary patch, it should not be relied upon as a permanent repair. My primary recommendation is to have a licensed roofing contractor properly reinstall the flashings.

Flashing is lifted. This can allow water to leak around the flashing and to areas below, particularly with wind blown rain. Corrections or repairs are suggested to prevent leaking.

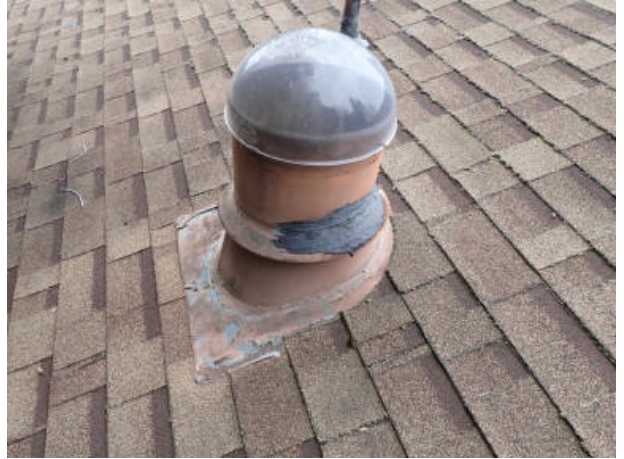
Asphalt patching compound has been used at the perimeter of the skylight. This may have been done as a preventative measure or may represent past leaking. I recommend any interested party consult with the current owner for any applicable information regarding the history of this roof. If no documentation can be provided, a licensed and qualified roofing contractor should be consulted to examine these areas and make corrections, if needed.

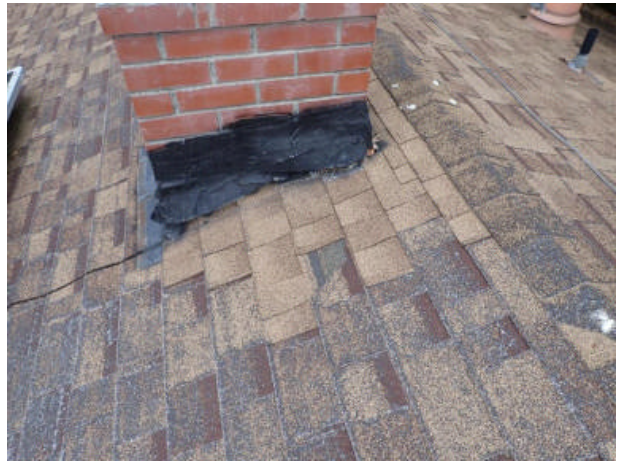
**Chimney:**

Asphalt patching compound (mastic) has been applied to the chimney flashings. This indicates an active or intermittent leak. While mastic can be useful as a temporary patch, it should not be relied upon as a permanent repair. My primary recommendation is to have a licensed roofing contractor install proper flashings and/or make the necessary corrections/repairs.

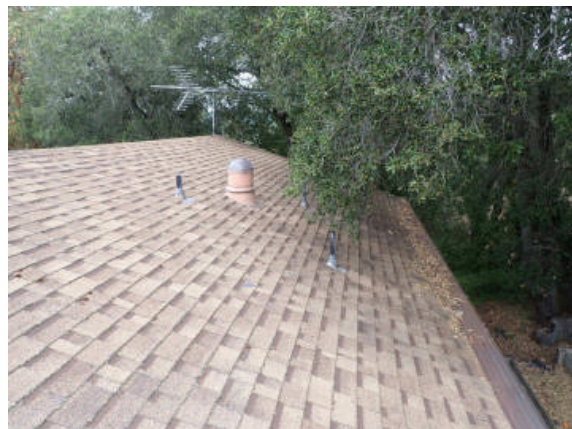
Branches are close to the roof. This can damage and abrade the roof as well as provide a path to the roof for rodents. Trees should be trimmed away from the structure and debris cleared off of the roof.

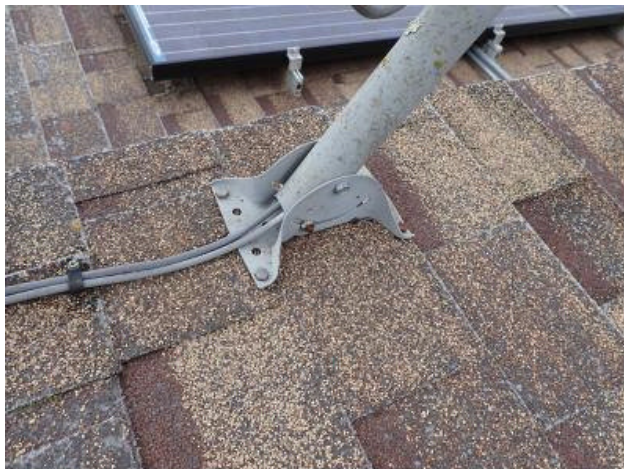
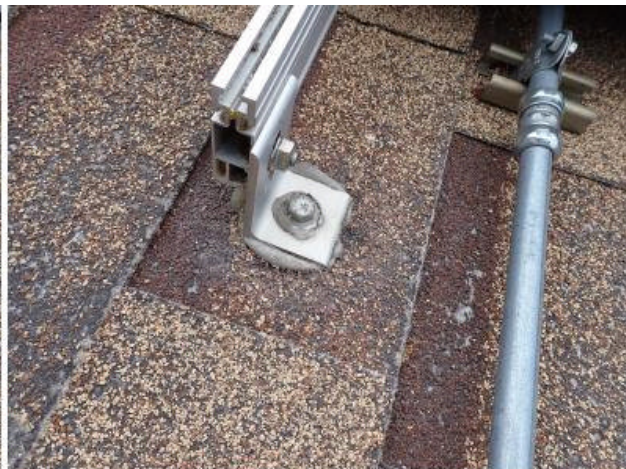
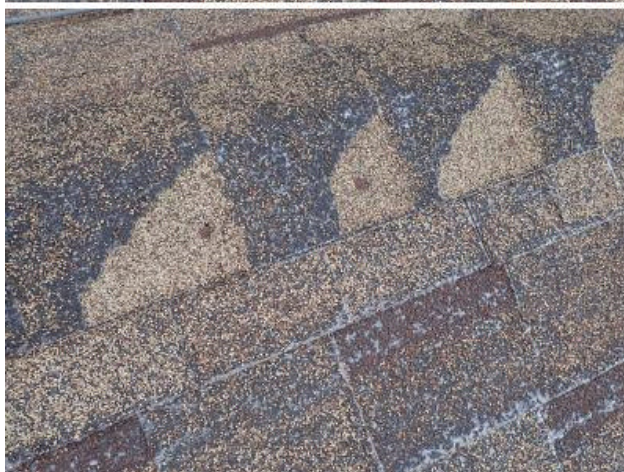
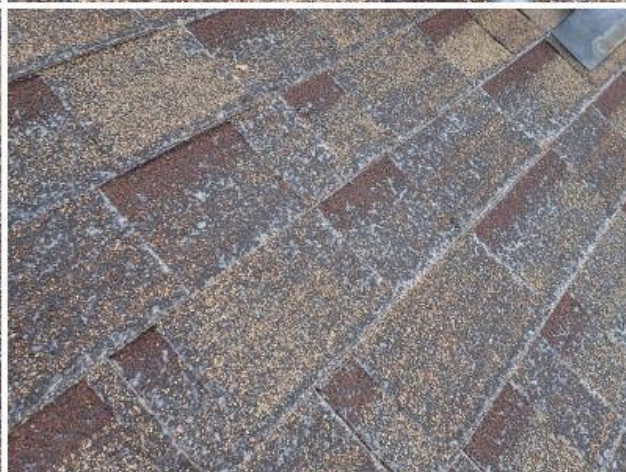
Condition:

The "dish" antenna as well as the solar panel brackets have been attached to the roof through the shingles. My primary recommendation is to remove or relocate the dish hardware and install properly flashed solar panel mounting hardware concurrently with roof replacement.

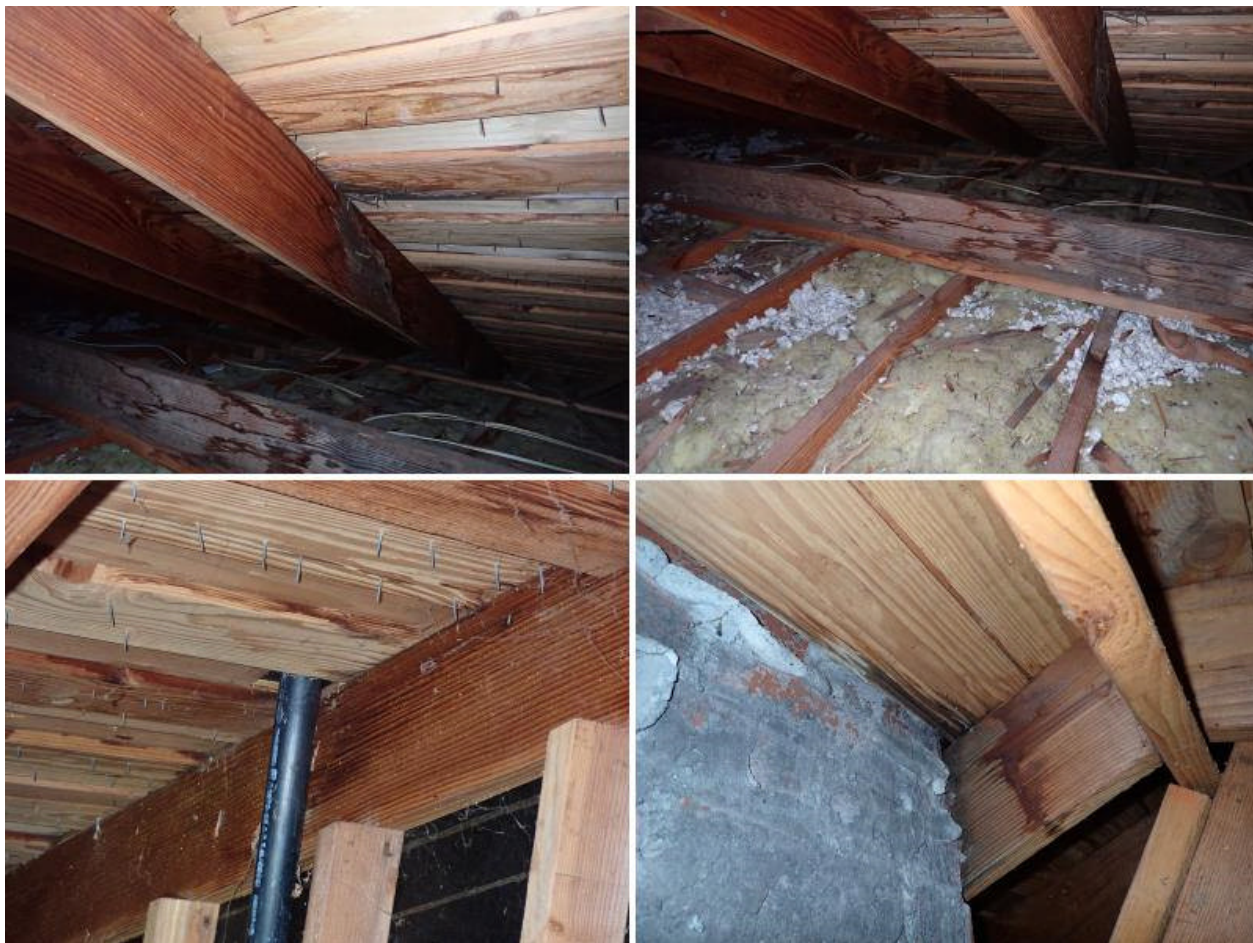
Leaks:

Moisture staining was found on the roof sheathing at various areas throughout the attic. While some of this likely represents previous leaking, I do not know if all of it is old or if some of this is more recent. As noted in the exterior section of the report, the roof is in poor condition and may be leaking. I recommend consulting with a licensed roofing contractor regarding installation of a new roof.

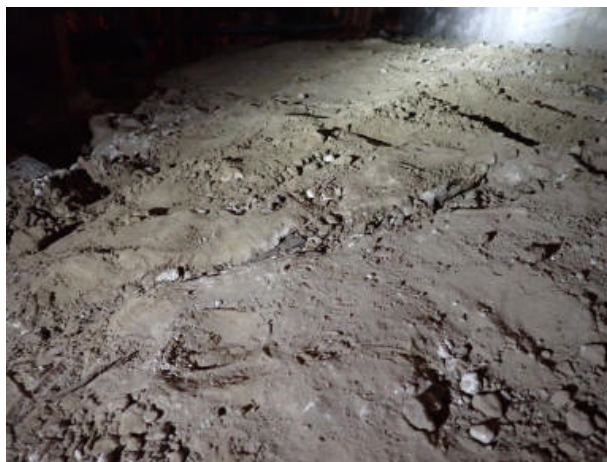
Soil erosion and dry water channels were observed, indicating that water will flow through the foundation crawlspace during periods of rain. Erosion can usually be controlled by installing a drainage system uphill from the building and extenders on the roof gutter system. A licensed landscape contractor should be consulted regarding installation of drainage.

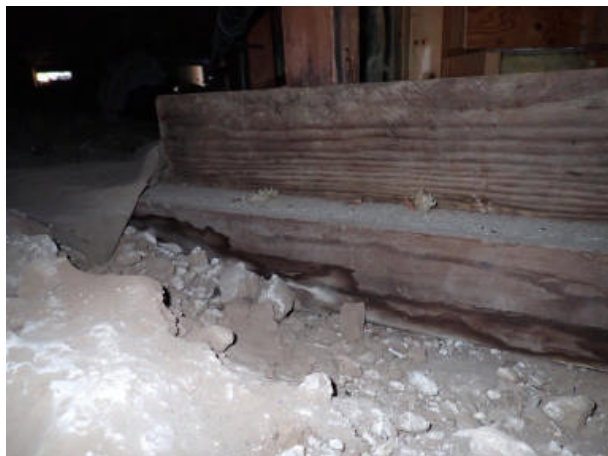
Wood members are in contact with soil. Wood should be isolated from soil or corrections made to help prevent decay/damage.

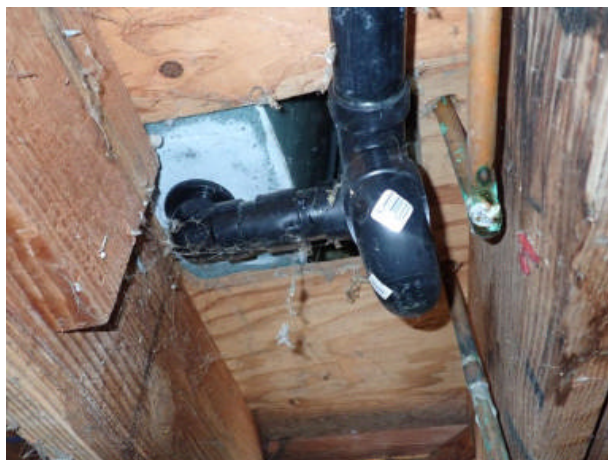
Openings were found in the subfloor sheathing adjacent to the tub drain piping. These openings can allow rodents access into areas under bathtubs and into wall cavities. While not required at time of original construction, I suggest screening any openings with a metal mesh.

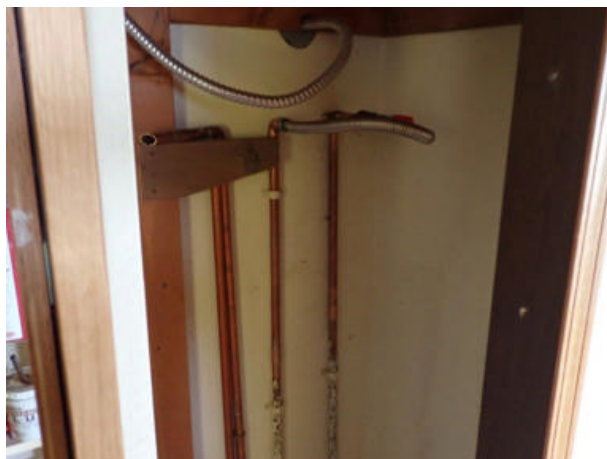
No water heater present. The client reported that the previous water heater was removed because it was leaking. I recommend installation of a new water heater by a licensed plumbing contractor.

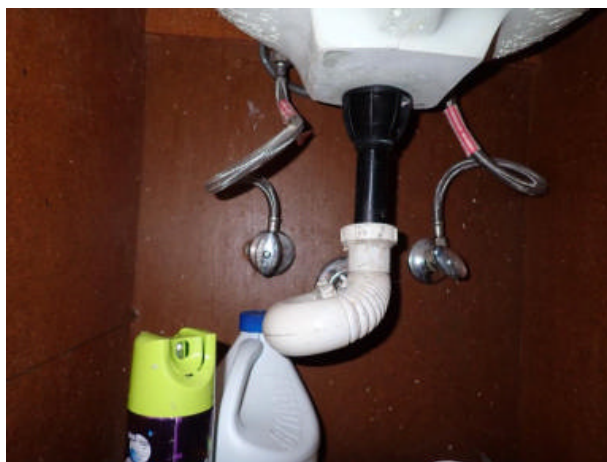
Older shutoff valves and drain fittings are present at interior plumbing fixtures. Client is advised that older valves often do not function properly and fittings are more prone to leaking due to aged washers and packing. Replacement of older fittings should be undertaken as a part of routine maintenance and repairs.

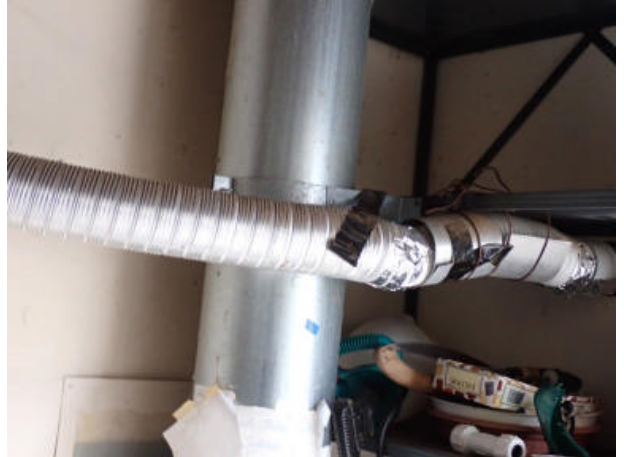
The dryer vent is nonstandard. Flexible ducting will collect lint and become clogged over time. I recommend replacement with a smooth-walled dryer duct.

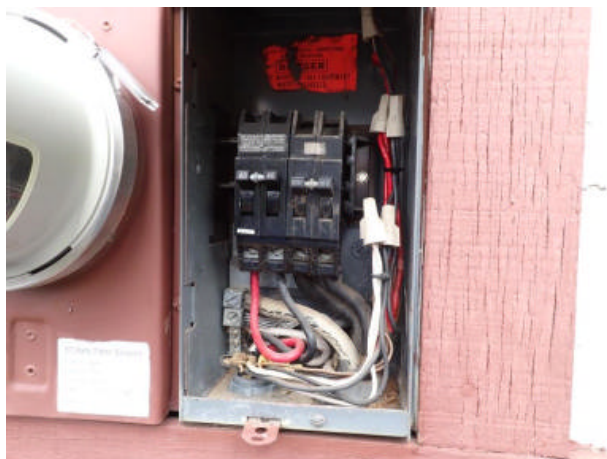
Dead-front is missing. The dead-front is a metal panel that allows access to the circuit breaker handles while it covers the electrical wiring and buss bars. Presently, the energized electrical circuits are exposed, which could allow an individual to come into contact with the energized circuits and be electrocuted. A new dead-front should be installed to prevent accidental contact with electrical wiring. Replacement screws should be the same as the screws originally supplied with the panel and should not be sharp/pointed.

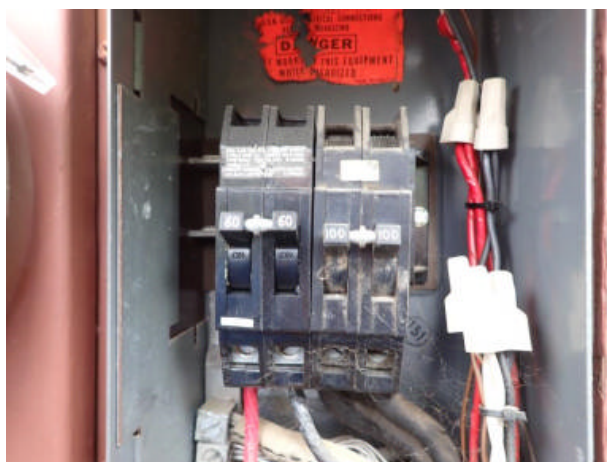
This type of panel often only allows for one double-pole circuit breaker, although two circuit breakers are present. I do not remove circuit breakers, but am concerned that this panel may have been modified to allow installation of the 60 amp double-pole breaker. I recommend review by a licensed electrical contractor and corrections, as needed.

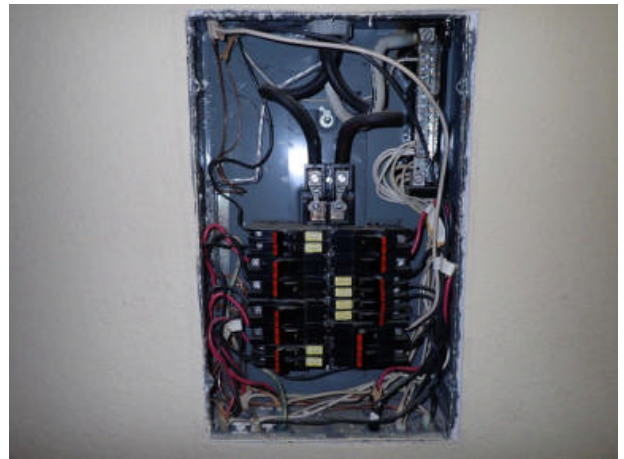
The panel and circuit breakers are Federal Pacific Electric (FPE). Some failure of this brand of circuit breaker (primarily failure of two pole breakers to trip) has been reported. As a result, many electrical contractors are unwilling to perform work on these panels, typically citing liability concerns and will advise replacement. In addition, these panels are no longer being manufactured and upgrade/replacement parts will be difficult and/or expensive to obtain. My primary recommendation for electrical systems with this brand of panel is replacement of the panel and evaluation of the wiring for any damage caused by overloaded circuits by a licensed electrical contractor. For relevant information regarding Federal Pacific Electric Panels, a search can be performed through the website maintained by Consumer Products Safety Commission (CPSC) at: <http://cpsc.gov/>

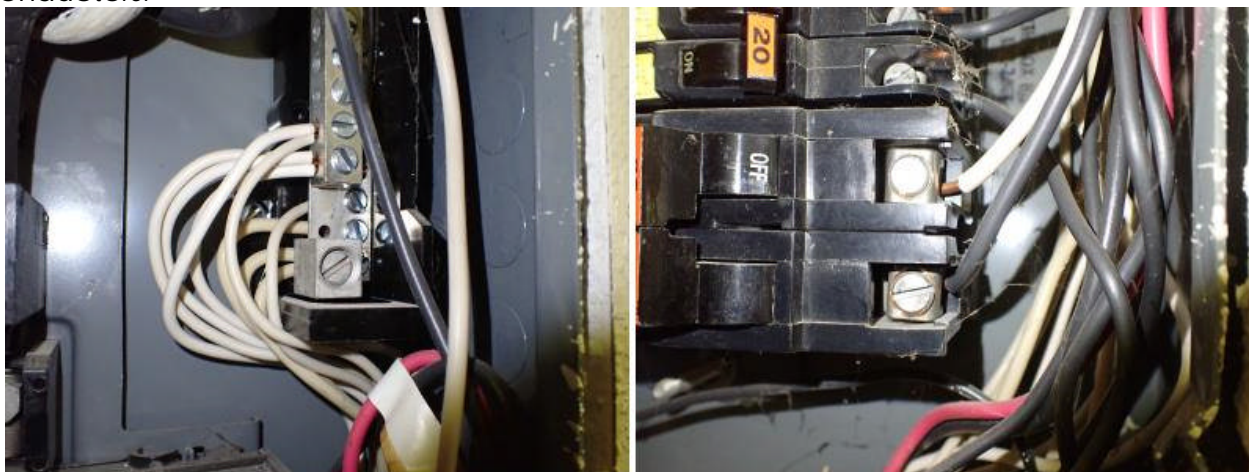
Conductors:

A white insulated wire has been connected to a circuit breaker. Current construction standards generally reserve white for the "neutral" conductor. When a white wire is used for a 240 volt circuit, the wire is typically wrapped with another color, such as black, to properly identify it as a voltage carrying conductor. Corrections should be made by a licensed electrical contractor.

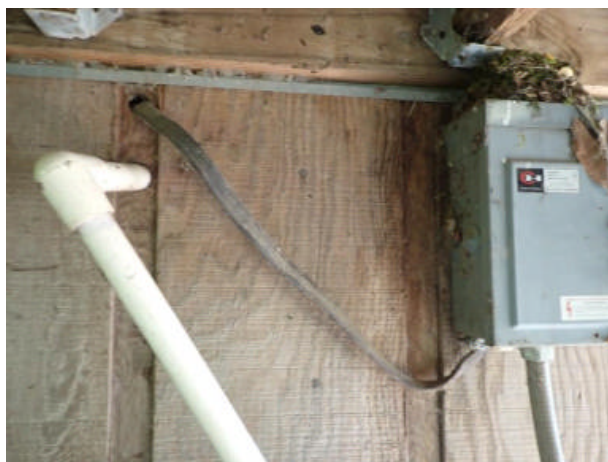
Receptacle outlets are not GFCI (ground fault circuit interrupter) protected. For more information, please refer to the GFCI notes above.

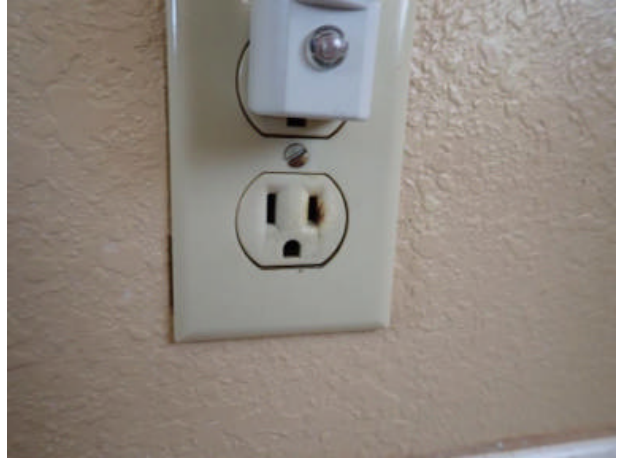
A scorched receptacle outlet was found in the half bathroom. As the contacts and wiring may be damaged as well, this outlet should be replaced and the feeding electrical wiring examined by a licensed electrical contractor. I recommend replacement with a GFCI device.

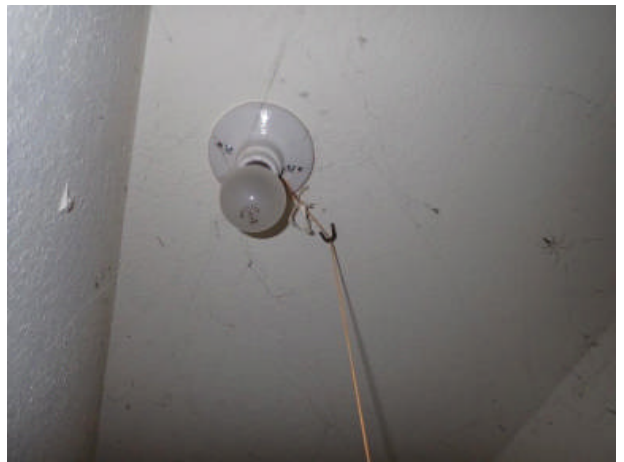
An unenclosed light bulb is present in the closet. Current construction standards do not allow light fixtures with bare bulbs in closets. Installation of a covered or recessed light fixture is advised.

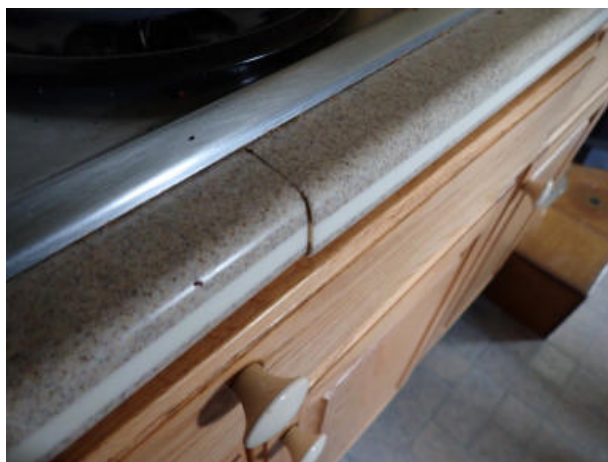
The counter is cracked adjacent to the cooktop. I recommend patching/repair, as needed.

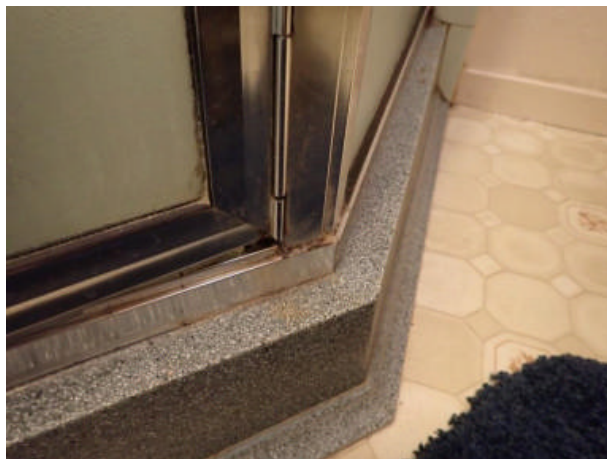
Shower enclosure will leak if sprayed directly. These are particularly vulnerable to leaking and this can allow moisture to damage the flooring. The enclosure should be resealed or reinstalled to stop the leaking and the shower head should be directed away from the door area.

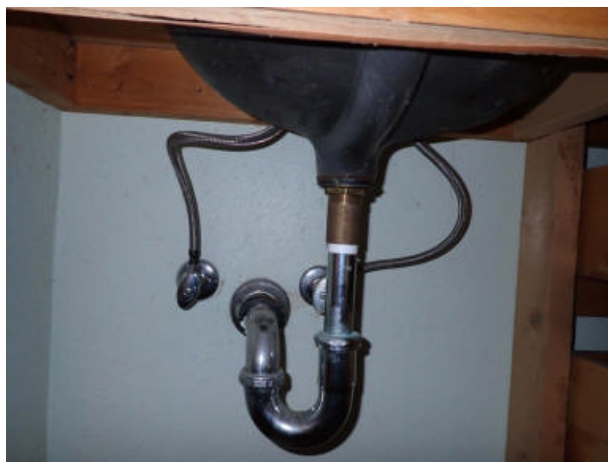
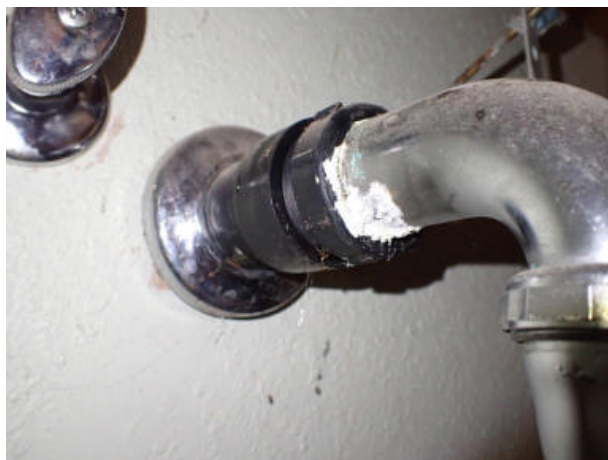
Staining on the plumbing under the sink indicates past leaking. While no active leaks were found at time of inspection, I recommend tightening all fittings and/or replacement of any corroded fittings to ensure that leaking does not reoccur. This area should be monitored for any further leaking that would require repair.

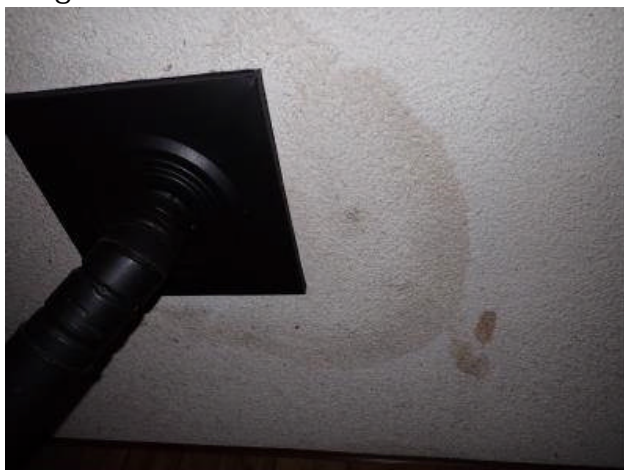
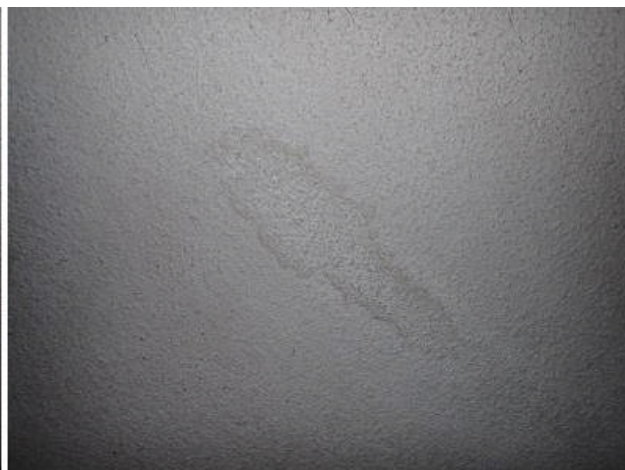
Ceilings:

The ceiling is moisture stained at the family room. I believe this is due to an active or intermittent roof leak. Client should consult with a licensed roofing contractor to review the roof and make corrections, as needed.

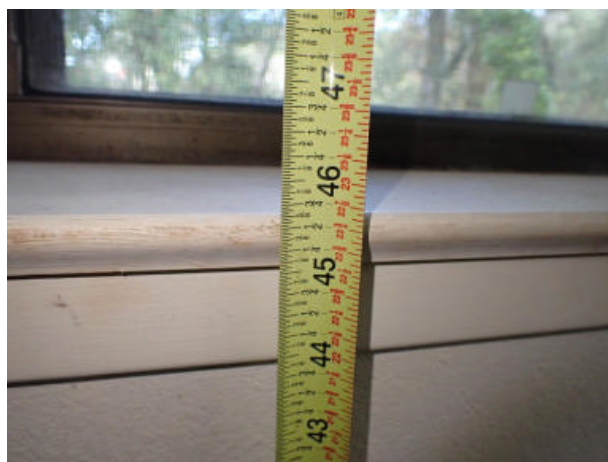
Windows in the bedrooms may be too high to serve as emergency egress. Windows in sleeping areas (bedrooms) should allow an individual to exit/escape the building in the event of an emergency. Window openings in bedrooms should be no less than 20 inches wide and 24 inches high, with a net opening area of at least 5.7 square feet and the sill should be no greater than 44 inches above floor level. Windows that cannot be opened or that have an inadequate opening size can prevent emergency/fire personnel from entering and/or prevent an individual from exiting the home in the event of an emergency. Increasing the window opening size would make this room safer.

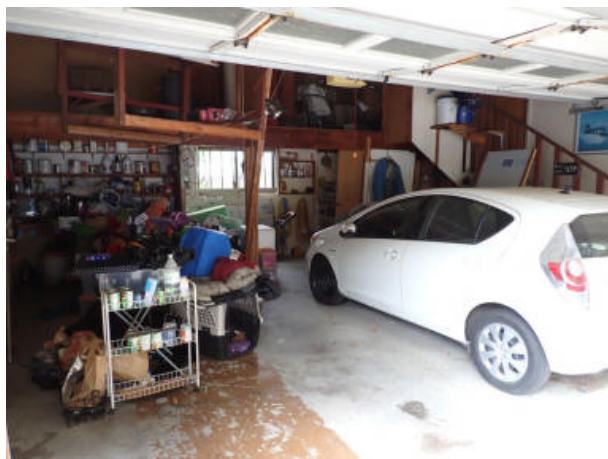
No guardrail present at the loft area. The open side is a potential fall hazard. Installation of a guardrail is advised.
