REPORTER

Take another look at polybutylene plumbing

by Kenny Hart, ASHI Technical Committee Member

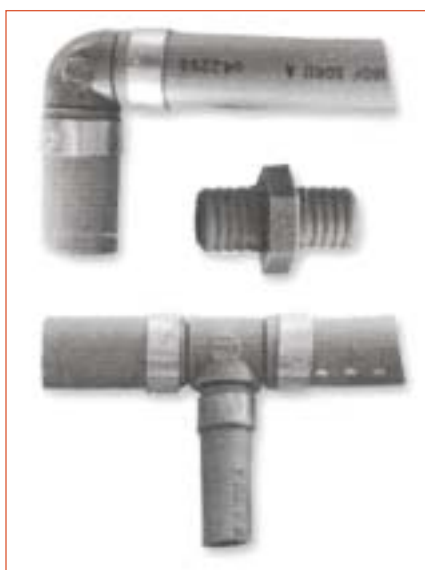
Plastic or acetal type fittings with aluminum crimp rings

Initially, aluminum crimp rings and plastic or "acetyl" fittings

were the standard for polybutylene connections. But over-crimped joints were showing up as split or snapped off fittings. Under crimped or missed crimps were also leaking and there were expansion rate concerns as well. Measures to stop the PB problems were put into place.

Problematic aluminum rings and the acetyl fittings caused concern after the walls went up. The industries' solution was to use copper or brass fittings along with copper crimp rings. In some localities, bags of the unused parts cart-

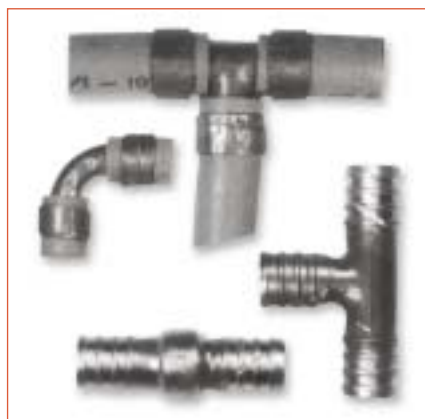
Copper fittings with copper crimp rings

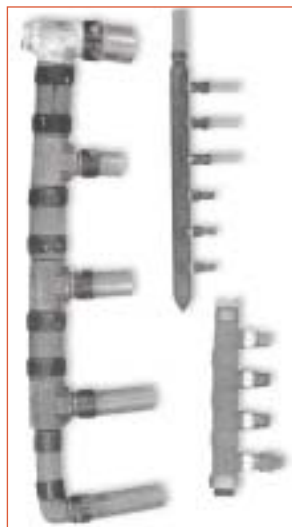
On site and factory made manifold units

“Home Run Plumbing”, involved pulling a series of 1/2" pipes from the hot and cold service locations behind each fixture to one location in or under the house.

By attaching the pipes to a large battery of tees or a manifold fed by one 3/4" hot or cold supply pipe, water was sent to each fixture through a dedicated pipe. PB was sold in 20-foot lengths and in

New tools and piping methods kept coming. Manifold units, both site built and factory manufactured, became popular. Manifold piping, often called

rolls. Because the rolls of tubing could be purchased at 100 feet or more, the need to install fittings along the way on a manifold system was eliminated – a plus because fewer fittings meant fewer potential leaks.

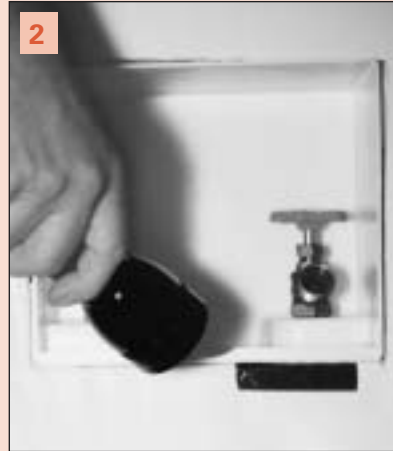
2
Chip or cut away a small section of wall within the frame area using the pencil mark for guidance. Check inside the wall with a flashlight for the gray pipe and metal ring.

On outer walls it may be necessary to pull the pipe wrap from around the pipe. This can usually be done with a screwdriver or other flat edge.

After your check re-install the frame.

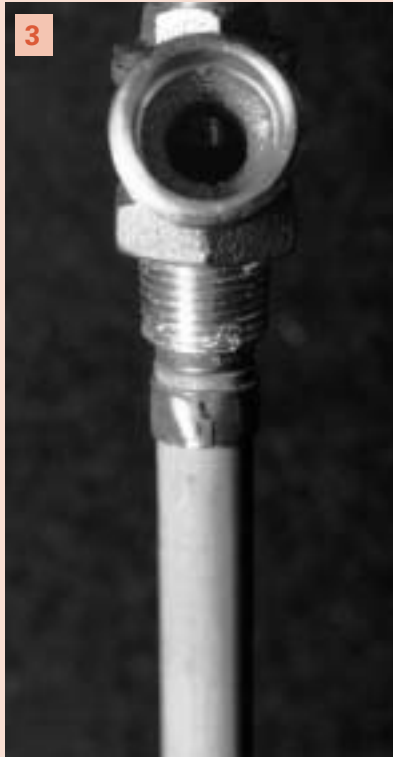
3
The removed valve at the left is typical of what you might see, but in some cases a compression fitting might be observed.
