Inspected for:
Zaphod Beeblebrox
3316 Golgafrincham Place
Margretha, CA

Full Circle Inspections, Inc.

05/13/2021

Re: 316 Golgafrincham Place
Margretha, CA

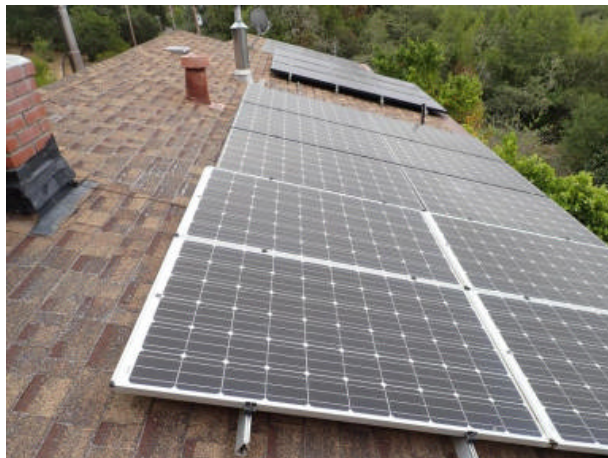
Limited review due to the presence of solar panels.
Viewed from accessible areas.

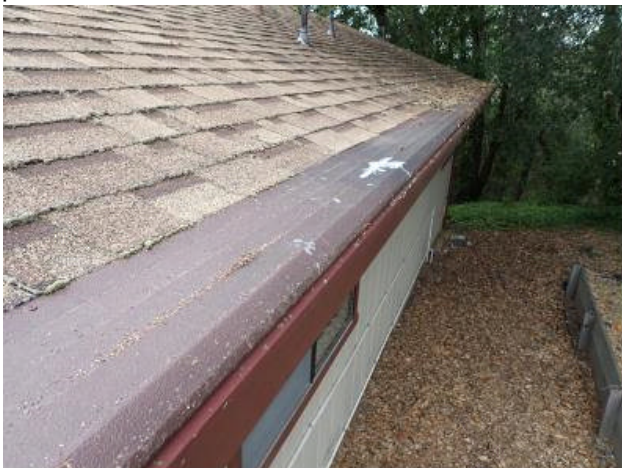
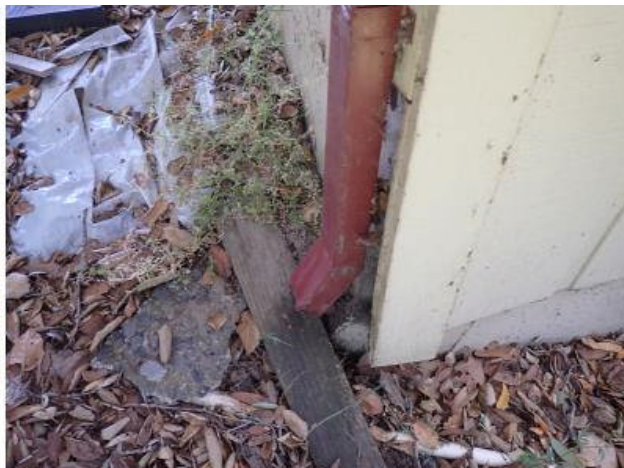
Metal gutters.

A "gutter helmet" is present on top of the gutters. As a result I am unable to review the interior of the gutters.

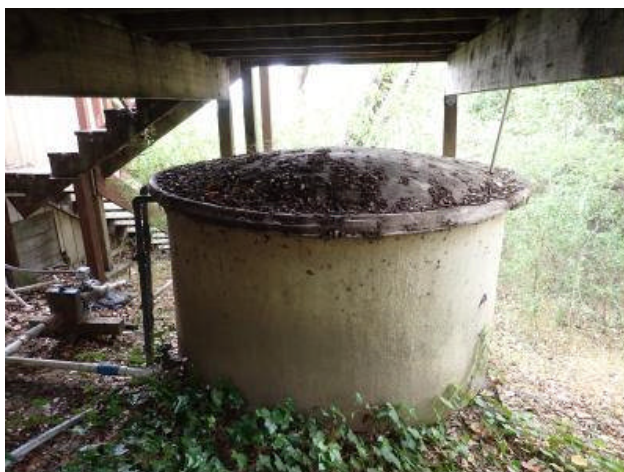
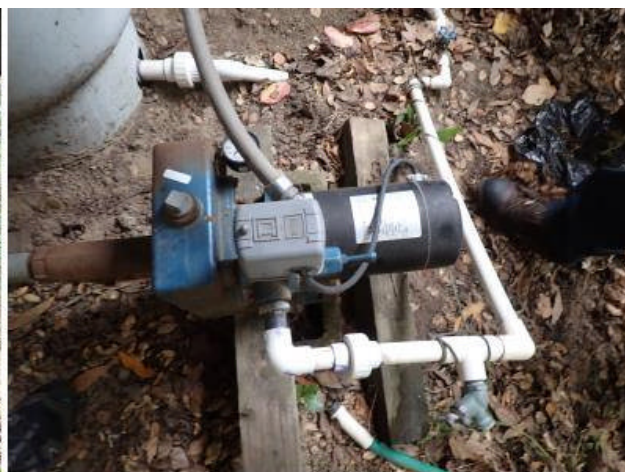
The client reported that the domestic water supply is provided by both a shared well as well as public utility. I am unable to verify water source. A well is a specialized system and due to the inaccessible nature of the pump and lines, beyond the scope of this inspection. Water pressure, quality and flow rate are a function of the well system. I recommend review of this system by a qualified well specialist.

A booster system, consisting of a storage tank, booster pump, and a pressure tank, is present under the rear deck. This is a specialized system and beyond the scope of this inspection. Water pressure, quality and flow rate are a function of the booster pump system. Review of this system by a qualified plumbing contractor is suggested.

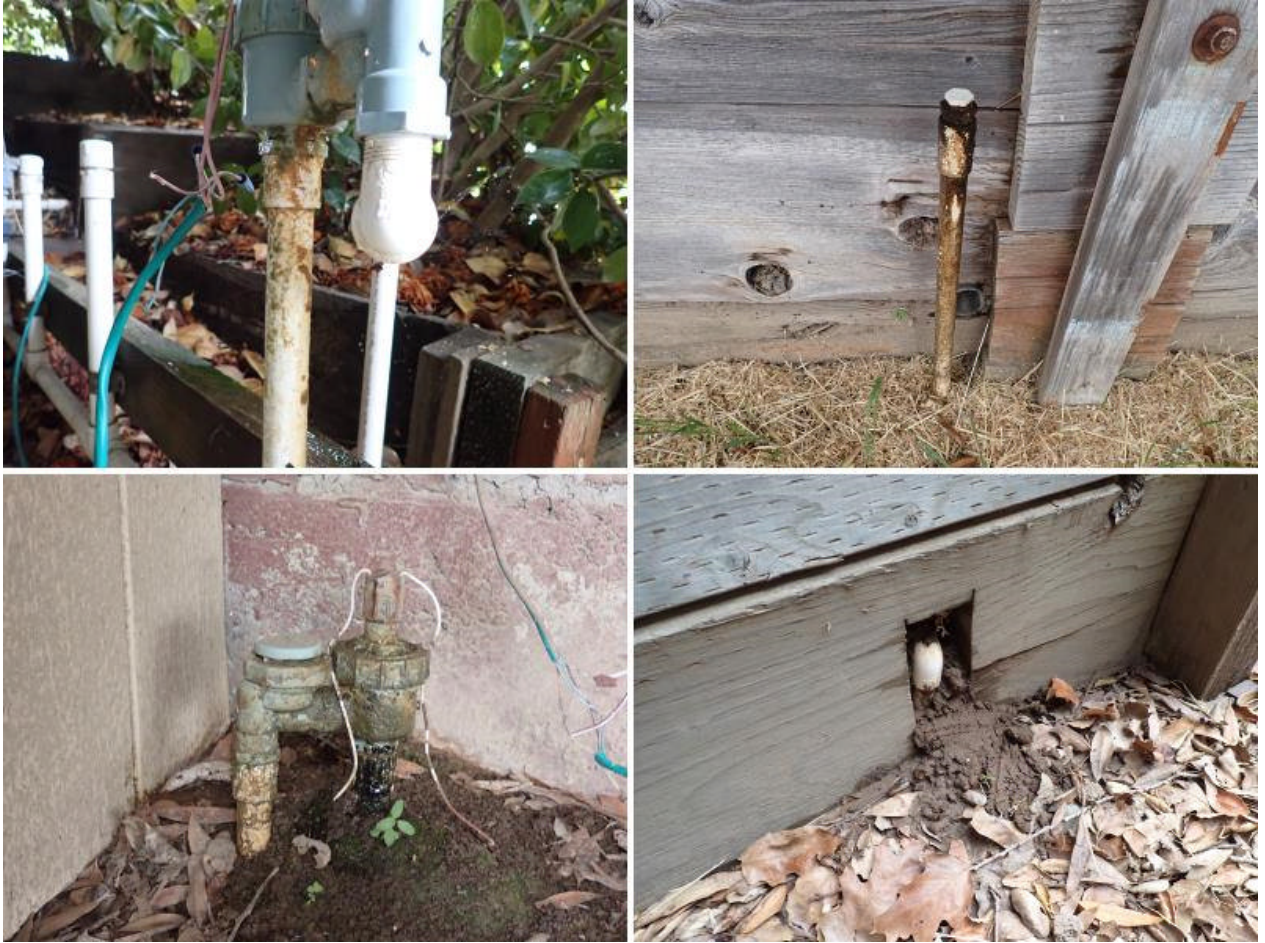
Where visible, distribution piping is copper and PVC.

PVC piping has been used in the attic as well as the foundation crawlspace area. PVC (polyvinyl chloride) piping is not approved for use as distribution piping. While this piping appears to be for the exterior irrigation and not for interior domestic use, PVC should not be used within the building envelope as it has a greater tendency to break/fail which can lead to significant amounts of water in the foundation crawlspace area. My recommendation is to replace this piping with a material that is approved for distribution piping.

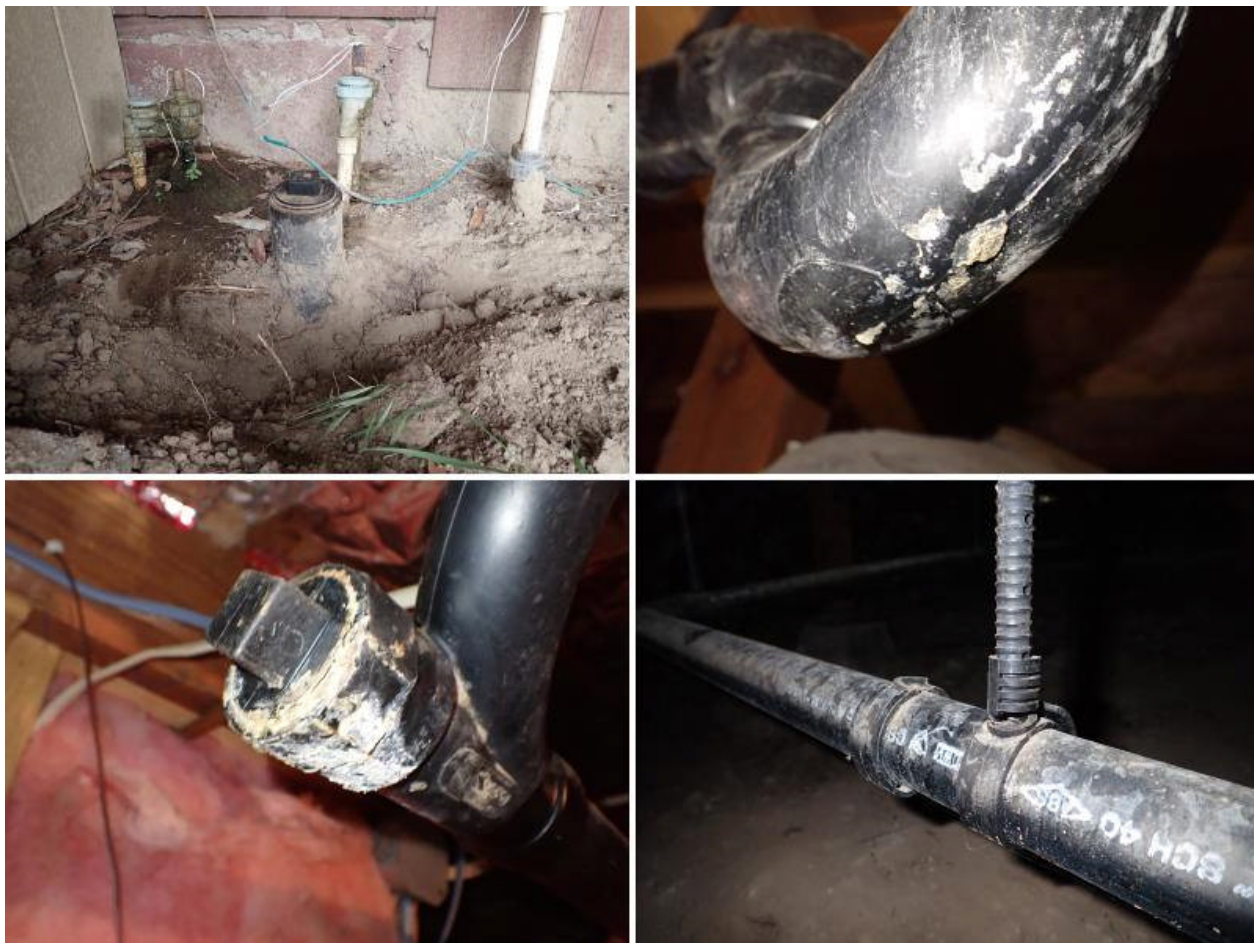
Where visible, drain lines consist of ABS (plastic) piping. A cleanout fitting was located at the left side.

Leaking plumbing was found at the drain pipes under the half bathroom sink and hall bathroom shower. A licensed plumbing contractor should be hired to make repairs or corrections, as needed.

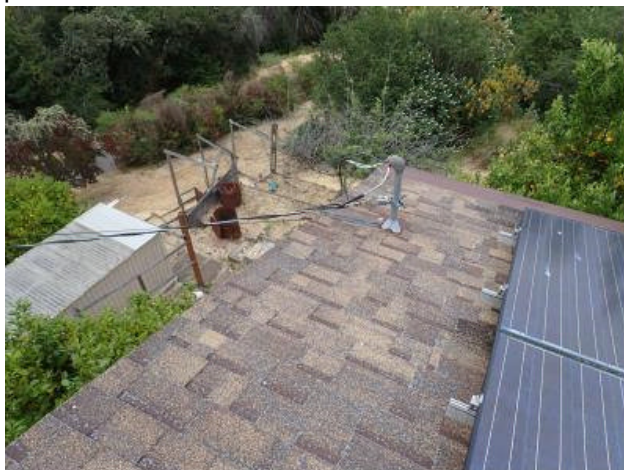
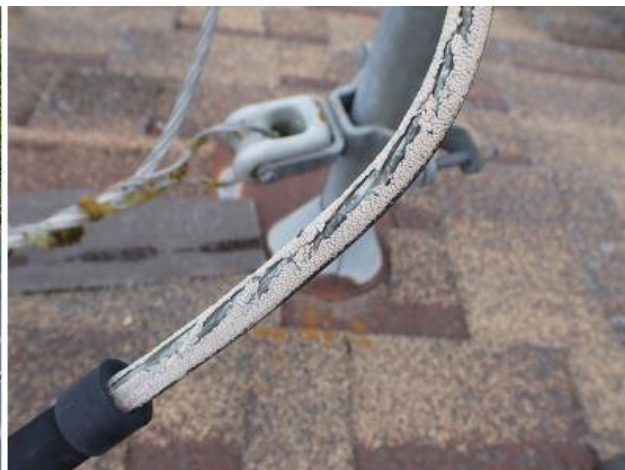
Service wires are overhead.

Service is 100 amperes, 240 volts.

Insulation on overhead conductors is deteriorated. In addition, the service drop is very close to the roof at the gable end. These cables should be replaced by a licensed electrical contractor.

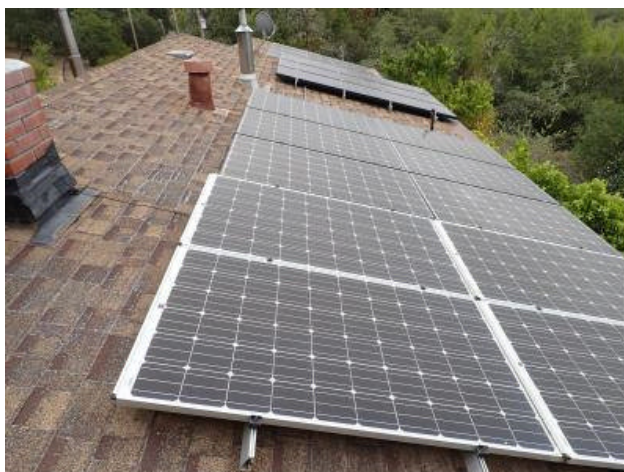
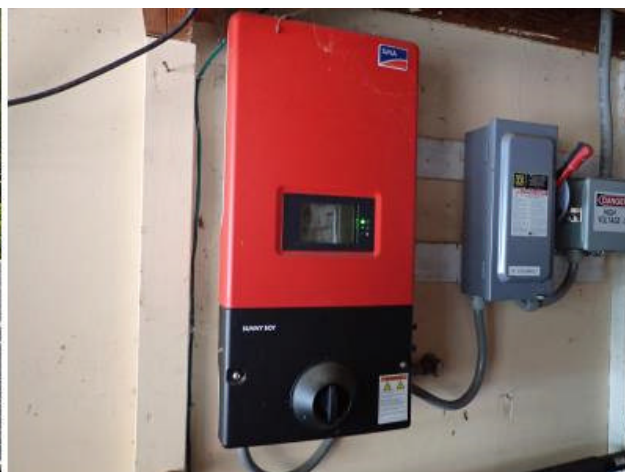
Solar photovoltaic panels are present on the roof. Evaluation of this system is beyond the scope of an inspection. I recommend review and any needed maintenance/service by a licensed and qualified solar or electrical contractor. The inverter system is located in the garage.

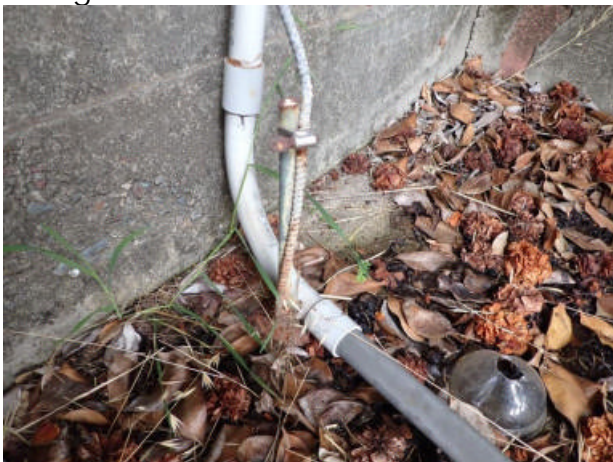
Ground rod is present.

The ground rod extends above soil level. Current construction standards require that ground rods be in contact with the earth for a minimum of 8 feet. As most standard ground rods are 8 feet long, the top of the rod should be even with the soil level. Corrections will likely require driving the rod so the top of the rod is even with soil grade. The appropriate person to make corrections is a licensed electrical contractor.

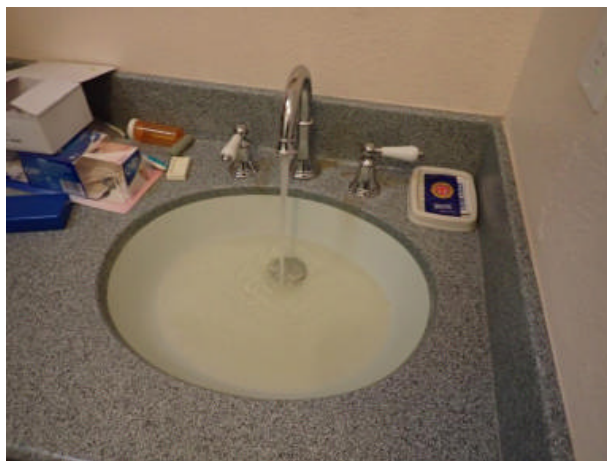
A flexible drain fitting has been used. Corrections should be made by a licensed plumbing contractor.

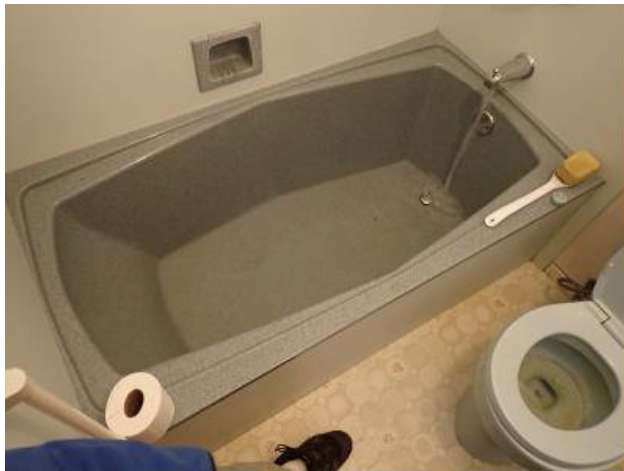
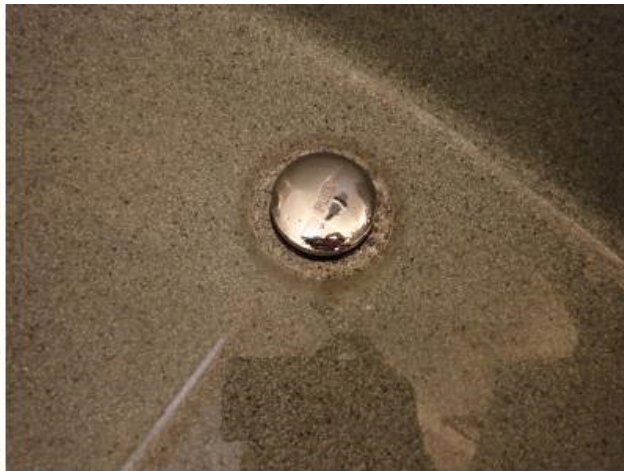
Fiberglass tub.

The mechanical drain stopper is inoperable. I suggest adjustment, repair or replacement.

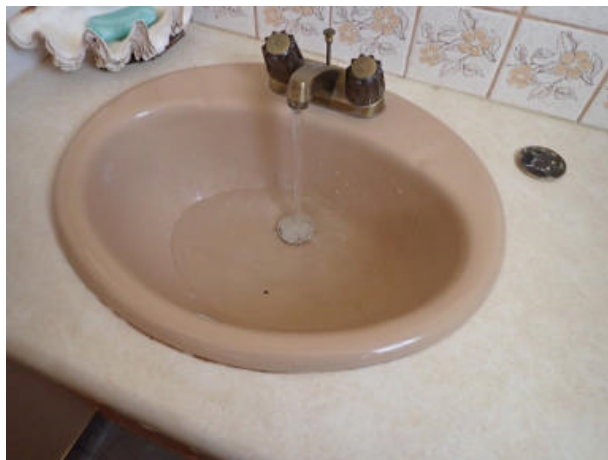
Staining on the plumbing under the sink indicates past leaking. While no active leaks were found at time of inspection, I recommend tightening all fittings and/or replacement of any corroded fittings to ensure that leaking does not reoccur. This area should be monitored for any further leaking that would require repair.

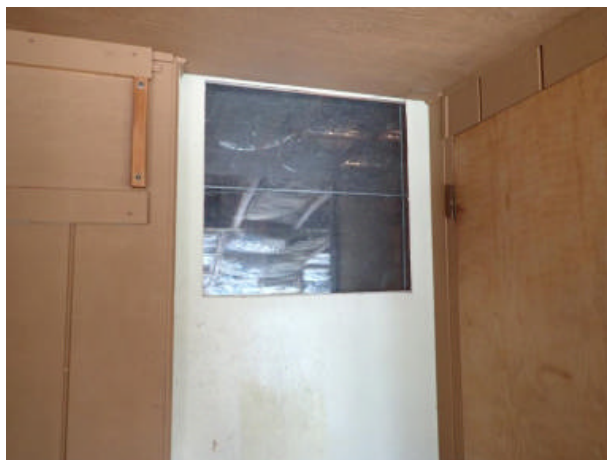
Glass in doors does not appear to be safety glass. Tempered or laminated glass is required by current construction standards to be installed in doors. When broken, annealed (non-tempered) glass will break into large shards which can cause significant lacerations, while tempered glass will break into smaller pieces and typically cause less injury. While safety glass may not have been required in this door at time of original construction, this is potentially unsafe and I suggest replacing the doors or upgrading any nonconforming doors with safety glass.

As a general rule, having a qualified locksmith re-key or change any exterior locks is advised.
